UNDERWATER BRIDGE INSPECTION REPORT

STRUCTURE NO. 05521

MISSISSIPPI RIVER

DISTRICT 3 - BENTON COUNTY

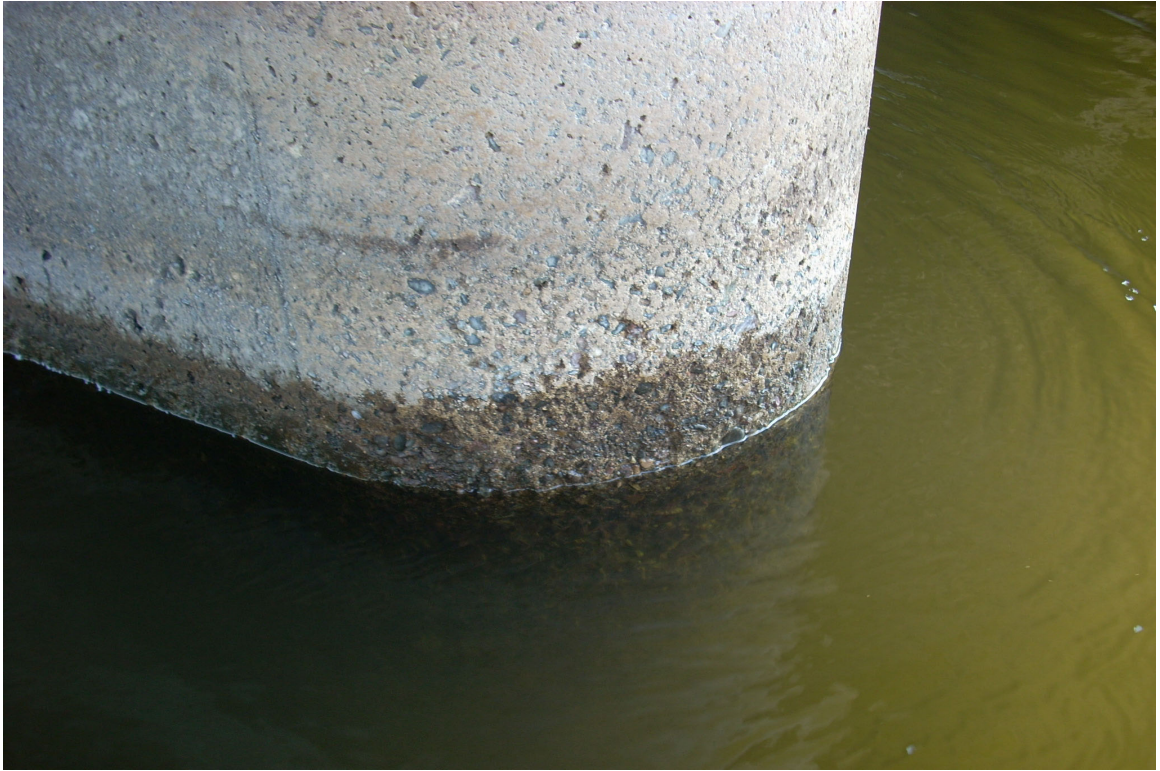
- (A) A band of minor scaling was observed at all piers from 3 feet above to 3 foot below the waterline with typical penetrations of 1/8 inch and a maximum penetration of 1/4 inch. The heaviest scaling was at the upstream nose.
- (B) A 2-foot-radius by 1-foot-deep scour depression with a minor accumulation of timber debris was observed at the upstream end of Pier 2.
- (C) The channel bottom consisted of sandy gravel and up to 5-inch-diameter cobbles with a maximum probe rod penetration of 4 inches.

Photograph 5. Scaling (typical) at upstream nose of Pier 1, Looking Southwest.

- (A) Reinspect the submerged substructure units at the normal maximum recommended (NBIS) interval of five (5) years.

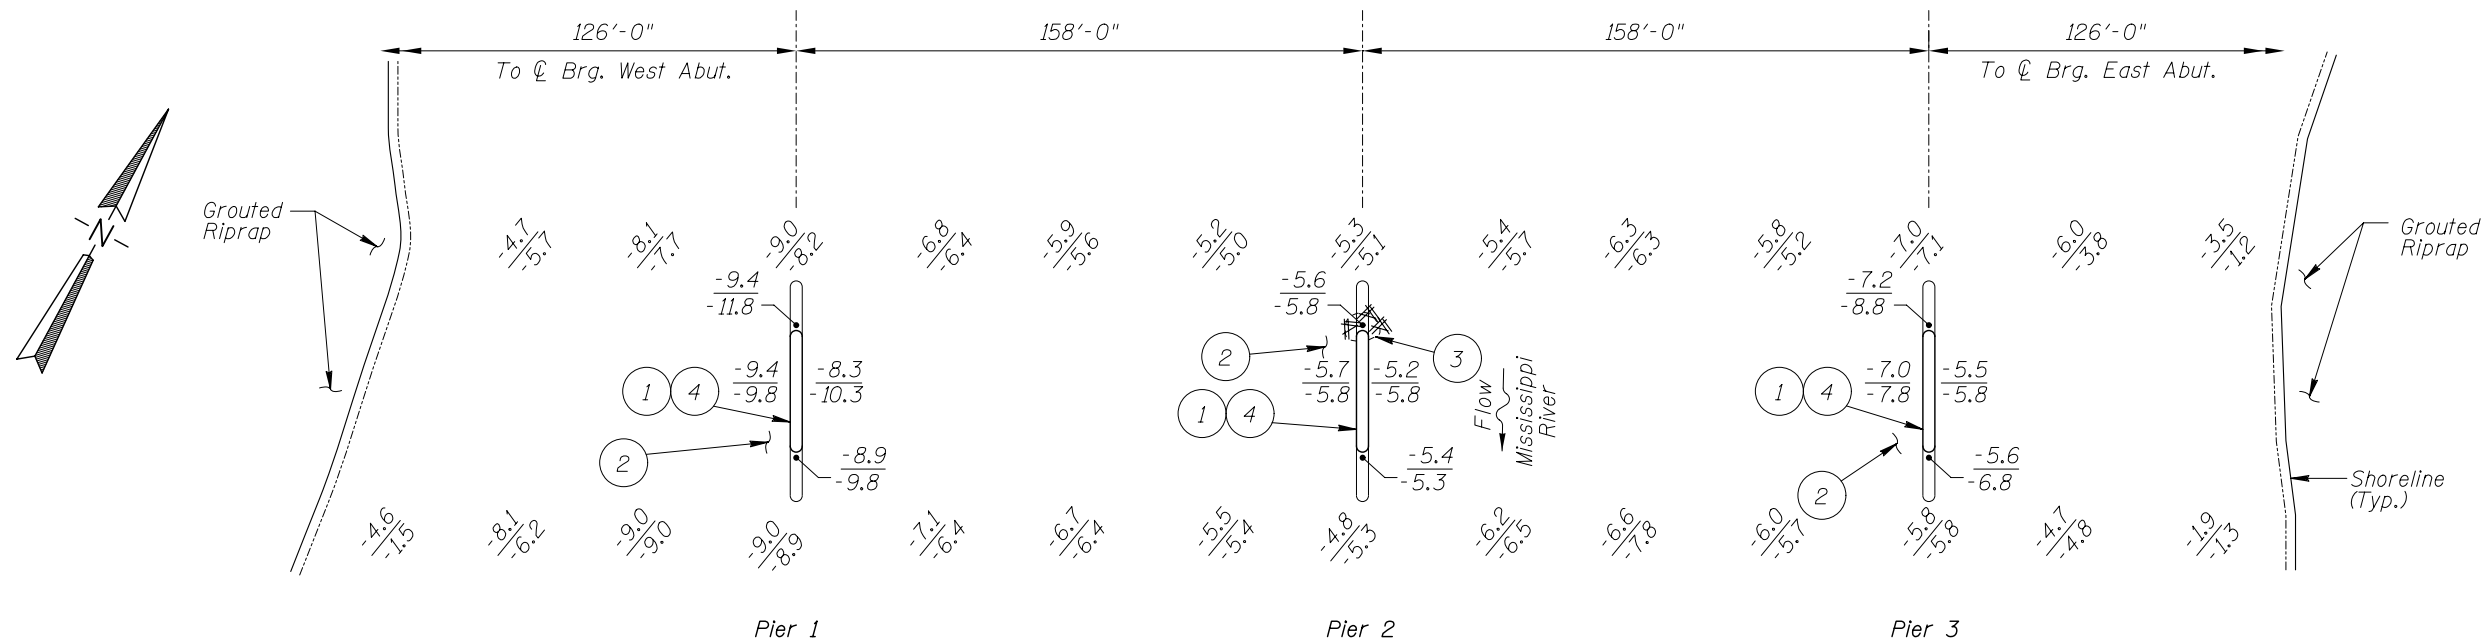
INSPECTION AND SOUNDING PLAN

- 1 A band of minor scaling was observed at all piers from 3 feet above to 3 feet below the waterline, with typical penetrations of 1/8 inch and a maximum penetration of 1/4 inch, with heaviest deterioration at the upstream nose.
- 2 The channel bottom consisted of sandy gravel and up to 5-inch-diameter cobbles with a maximum probe rod penetration of 4 inches.
- 3 A 2-foot-radius, 1-foot-deep scour pocket with a minor accumulation of timber debris was observed at the upstream end of Pier 2.
- 4 Above and below band of scaling concrete was smooth and sound.
